Arbitration - Smith

**Technical Report**

**TF200 Customer Complaint**

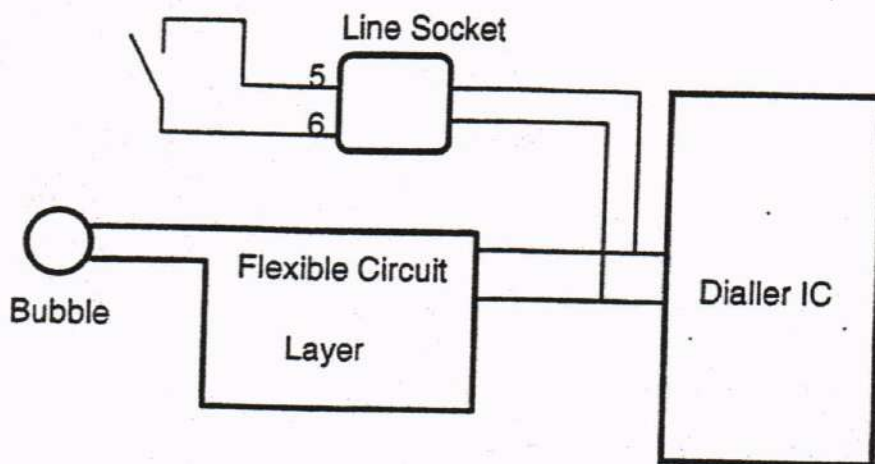
**Figure 1. Hookswitch configuration in the TF200**

The TF200 can be made to go off-hook either by lifting the handset or by connecting pins 5&6 at the line-cord socket. This facility was provided to allow expansion modules to be fitted to the TF200. If the phone is taken off-hook by connecting these two pins, the hookswitch part of the flexible circuit layer is not used. (figure 1)

The phone under investigation was taken on and off-hook repeatedly by connecting pins 5&6 and operated normally without any delay in returning to its on-hook state. This strongly suggested that the problem was related to the operation of the flexible circuit layer.

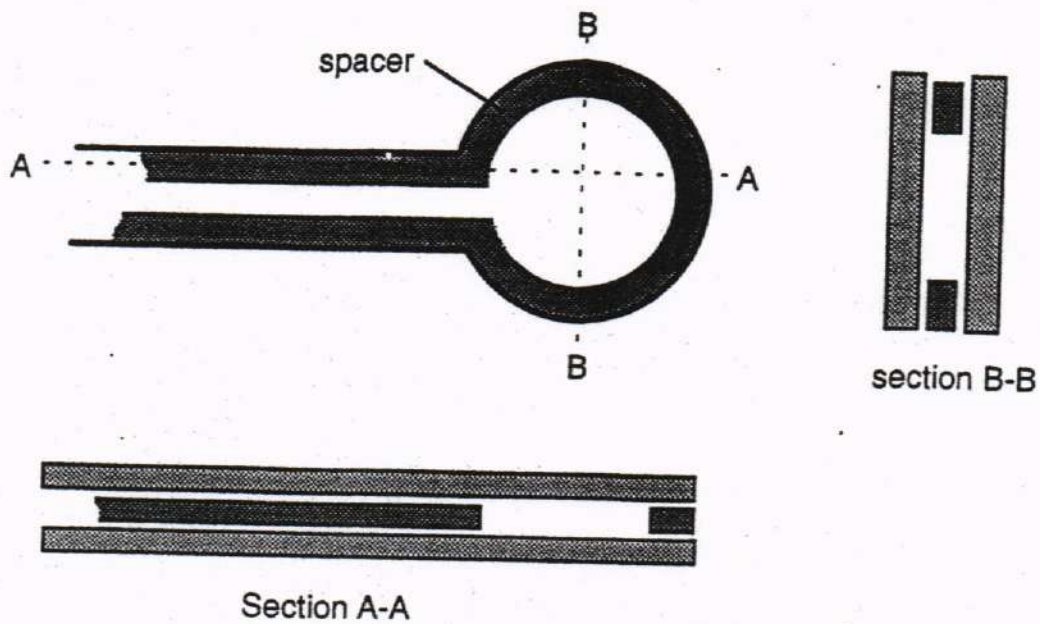
**Figure 2. Diagram of hookswitch Bubble construction**

It was thought that some of the sticky residue may have somehow entered the "bubble" that forms the hookswitch causing the two surfaces to stick together for a short time after the pressure is released. The "bubble" is formed by glueing two sheets of plastic together with a spacer in between. For reliable operation the seal around the bubble needs to be air-tight and thus, unless defective, could not allow the entry of any liquid.

The glue seal on the flexible circuit layer from the phone under investigation was visually inspected appeared to be satisfactory. (figure 2) The sticky residue is brown in colour and no discolouration is evident in the area of clear plastic around the outer perimeter of the bubble. This suggests that no liquid has managed to enter the bubble.

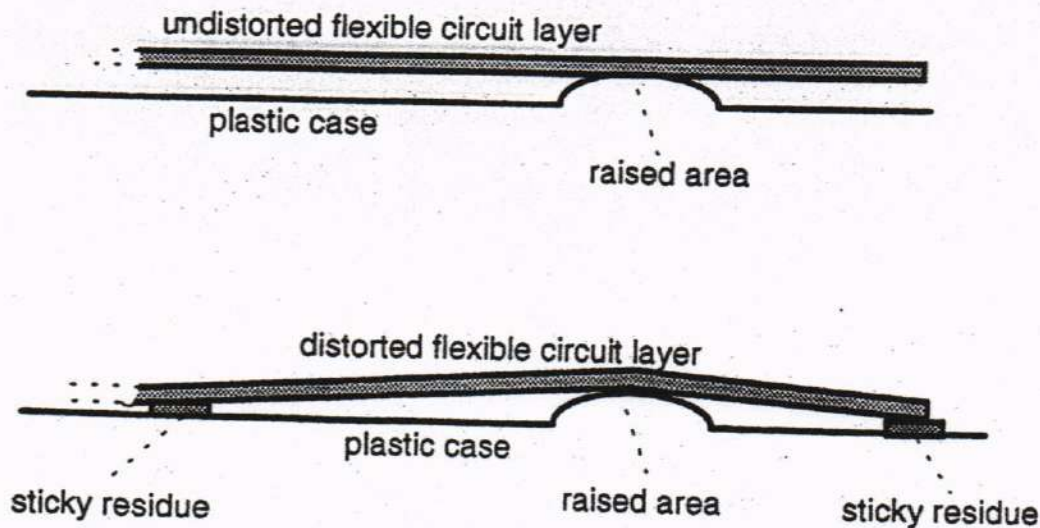
**Figure 3. Flexible Circuit Layer in undistorted and distorted shape when stuck to the case.**

The sticky residue in combination with the extra raised area in the plastic case has caused the problem of delayed return to on-hook conditions. The sticky residue is found either side of the raised area and when the phone is taken off-hook the flexible circuit layer is pressed against this sticky surface. **It is thought that after the handset is replaced and the pressure is removed the circuit layer remains stuck to the plastic case. Because the surface is not flat the flexible circuit layer is distorted sufficiently to cause the switch function in the bubble to operate.** Sometime after the handset is replaced (about 15 seconds) a part of the flexible circuit layer becomes unstuck and it returns to its undistorted shape. The hookswitch then operates normally, returns to a very high resistance and the phone goes into an on-hook condition. (figure 3)

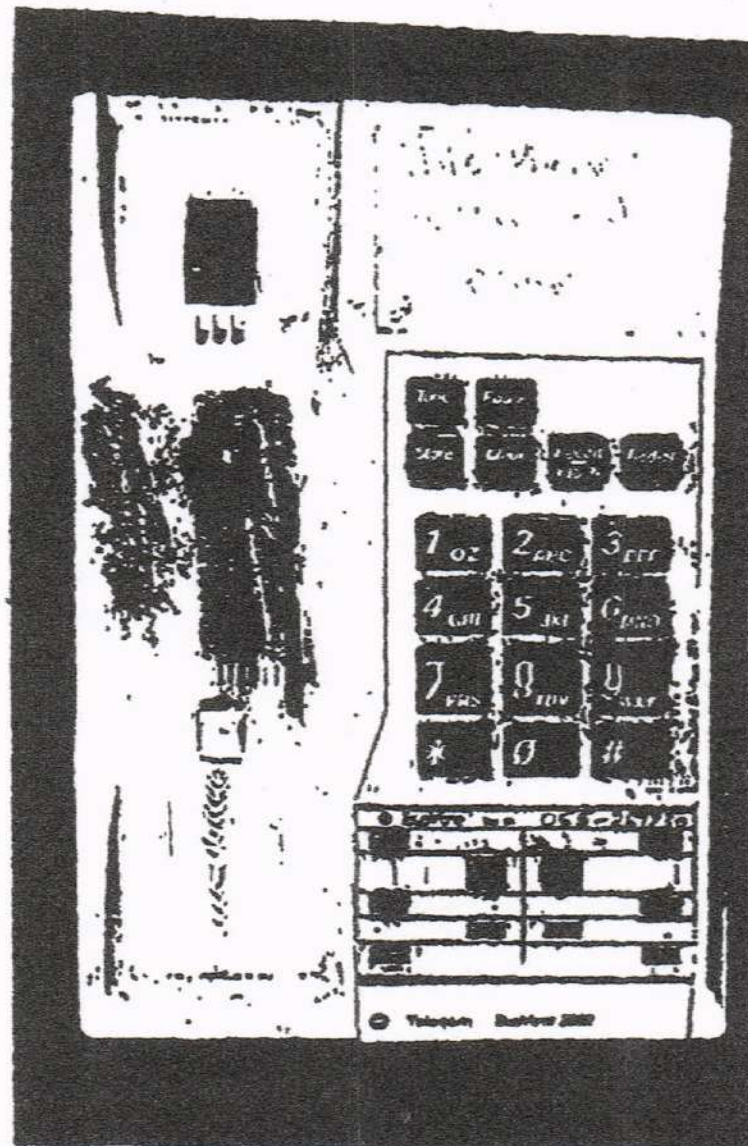
Photo 2. Front view with handset lifted indicating engraved markings on case

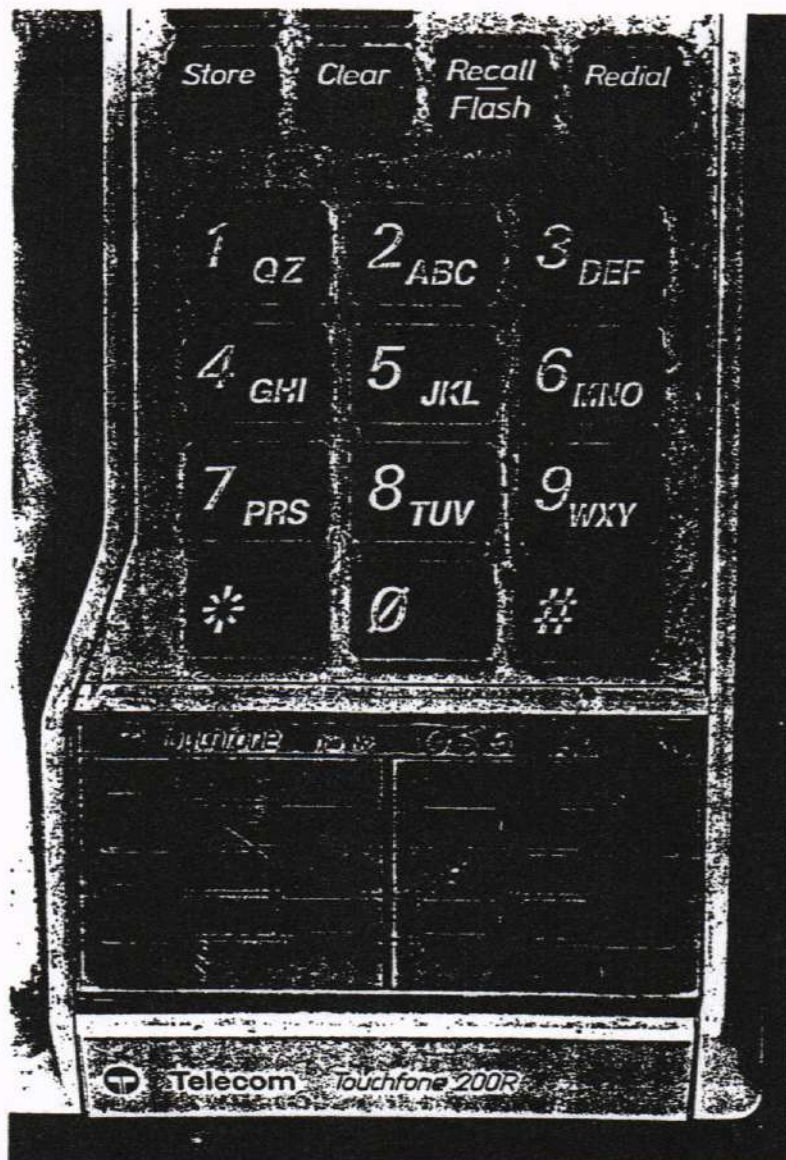
The suspect TF200 telephone when received was found to be very dirty around the keypad with what appeared to be a sticky substance, possibly coffee.

Photo 3. Close-up of keypad indicating dirty condition and showing customer's number

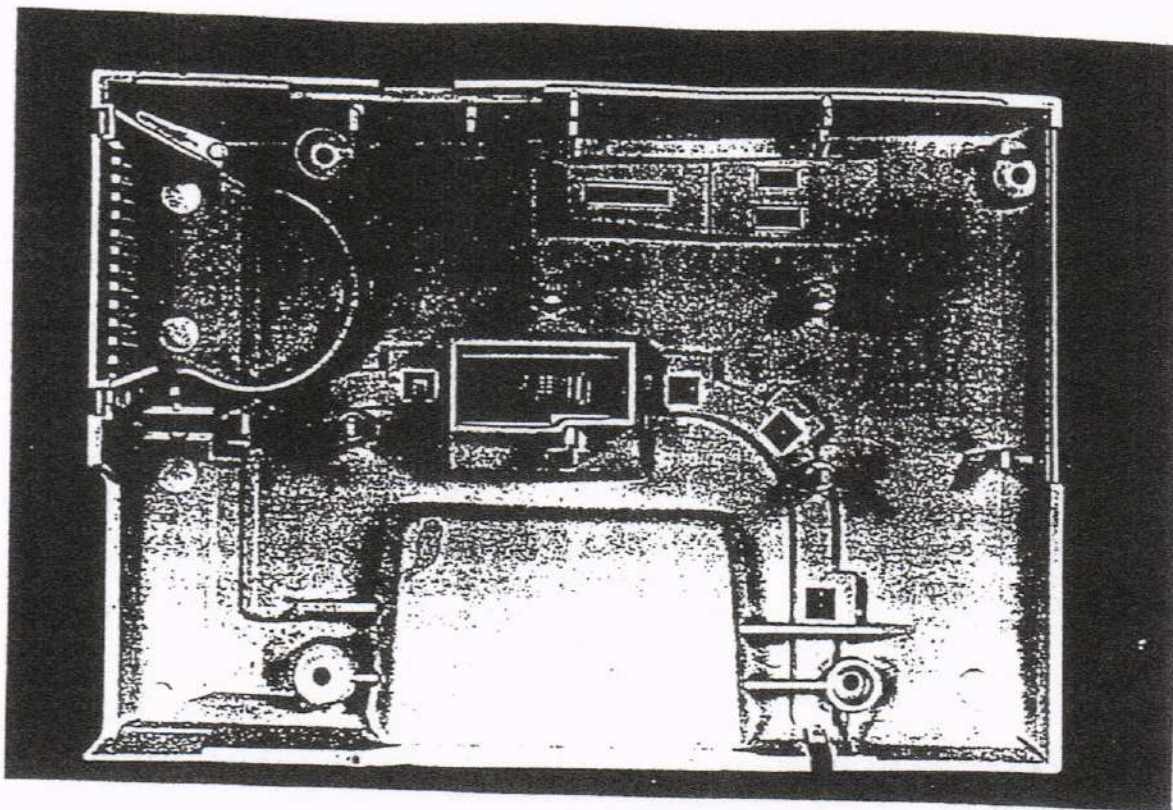
The phone was opened carefully and photographs taken to record the condition of various components. It was clearly evident that a brown coloured liquid had somehow entered the phone and spread internally before drying to a sticky residue. Of particular concern was a patch of this liquid residue under the part of the flexible circuit layer which extends beyond the keypad to provide the hookswitch function. It was found that this residue had caused the hookswitch extension to adhere to the upper part of the TF200 case when the various sub-assemblies were dismantled for individual testing.

This sticky residue has been analysed at TRL and contains chemicals typically found in beer. Coke and coffee (with sugar) were also considered but eliminated. It is difficult to be certain as there is a huge range of beers each with its own chemical composition. Further analysis can be done if it thought essential that this substance be identified conclusively.

Photo 9. Inside of back part of case showing residue of a brown liquid

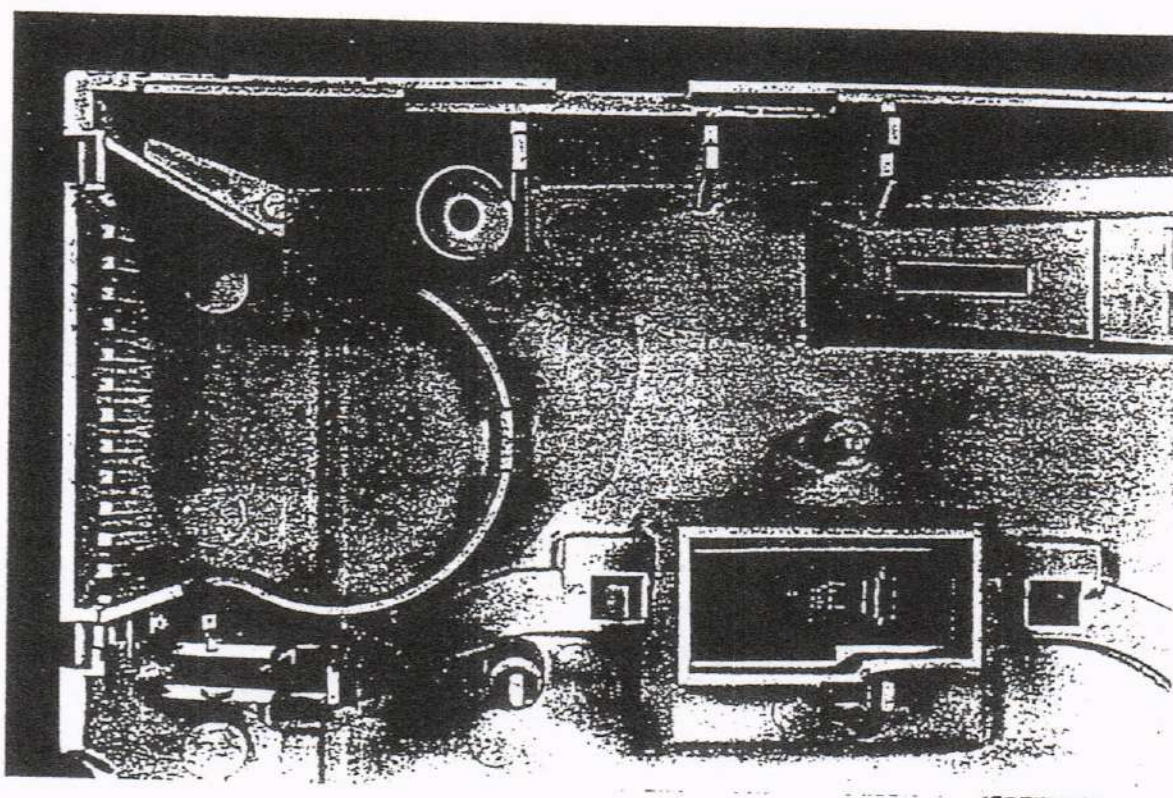
Photo 10. Close-up of the back part of the case in the area of the hookswitch

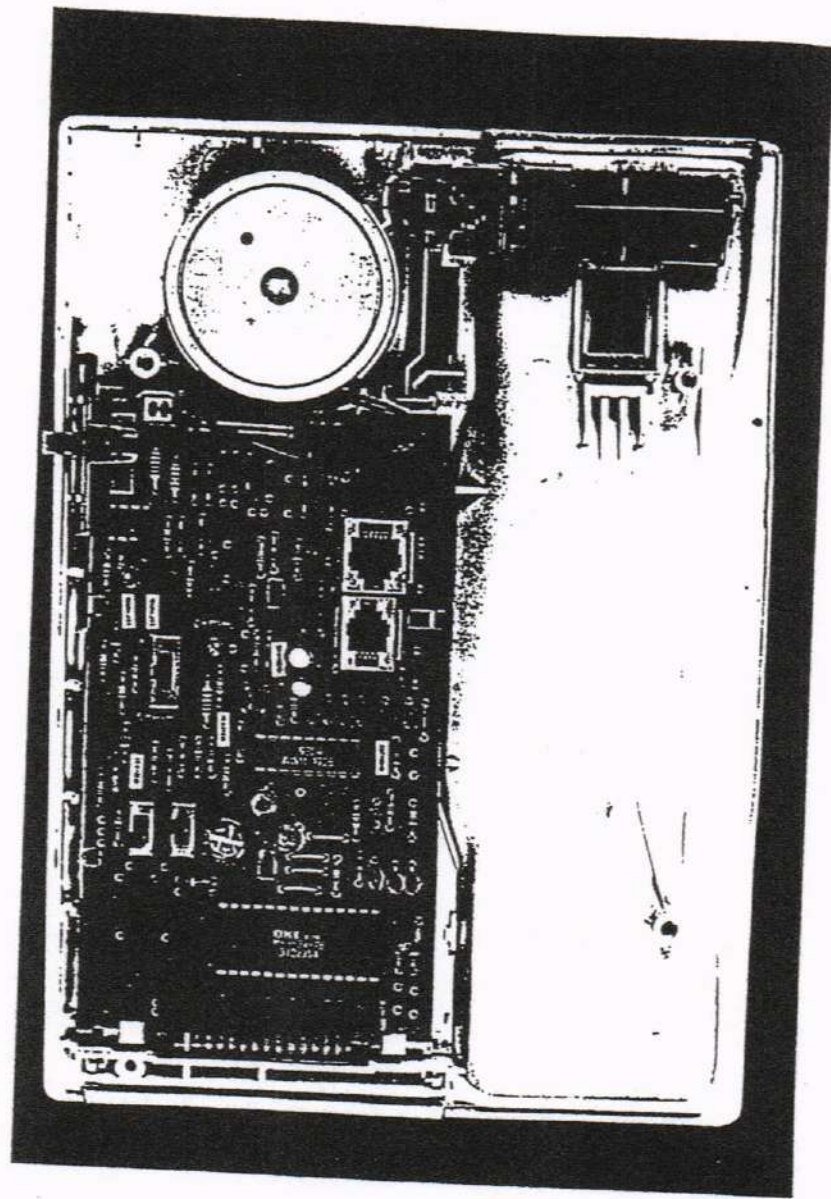
Photo 11. Inside of front part of case showing hookswitch extension and some traces of residue on the case

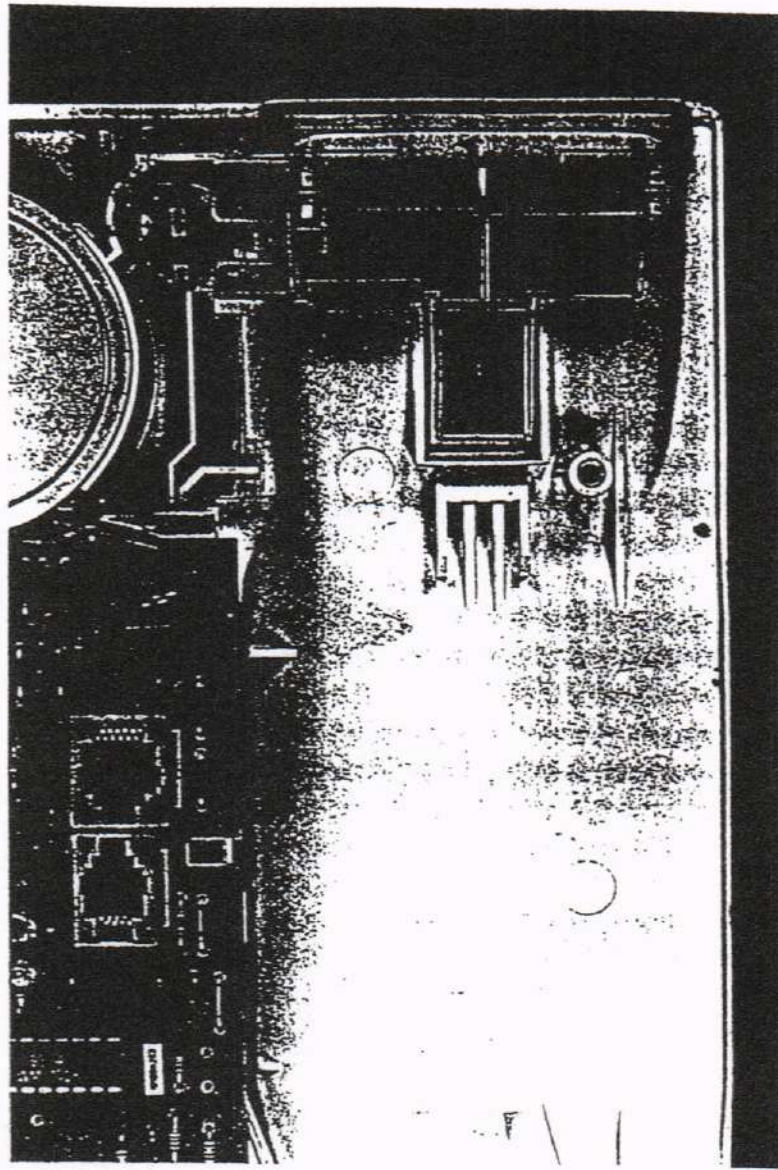
Photo 12. Close-up of the inside of the top case near the hookswitch

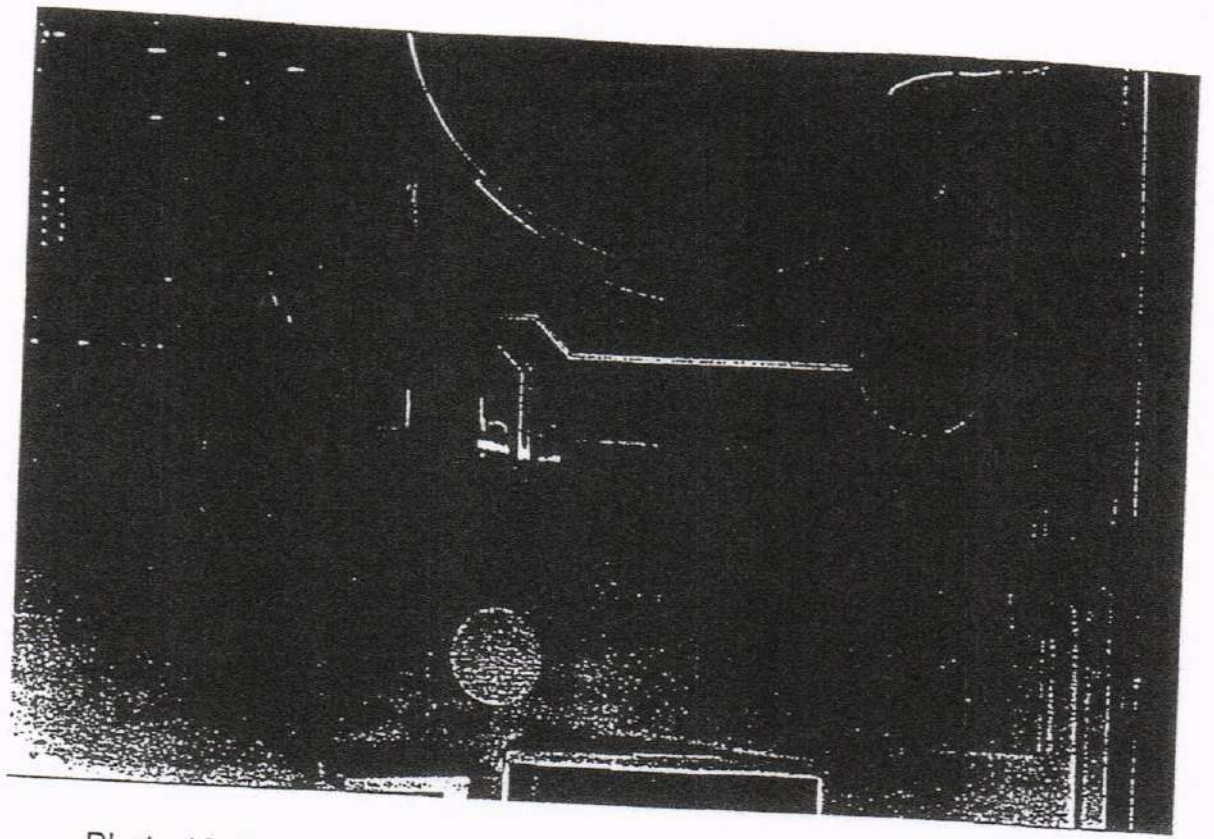
Photo 13. Close-up of inside of top case near hookswitch but with the hookswitch lever removed to show the hookswitch bubble.

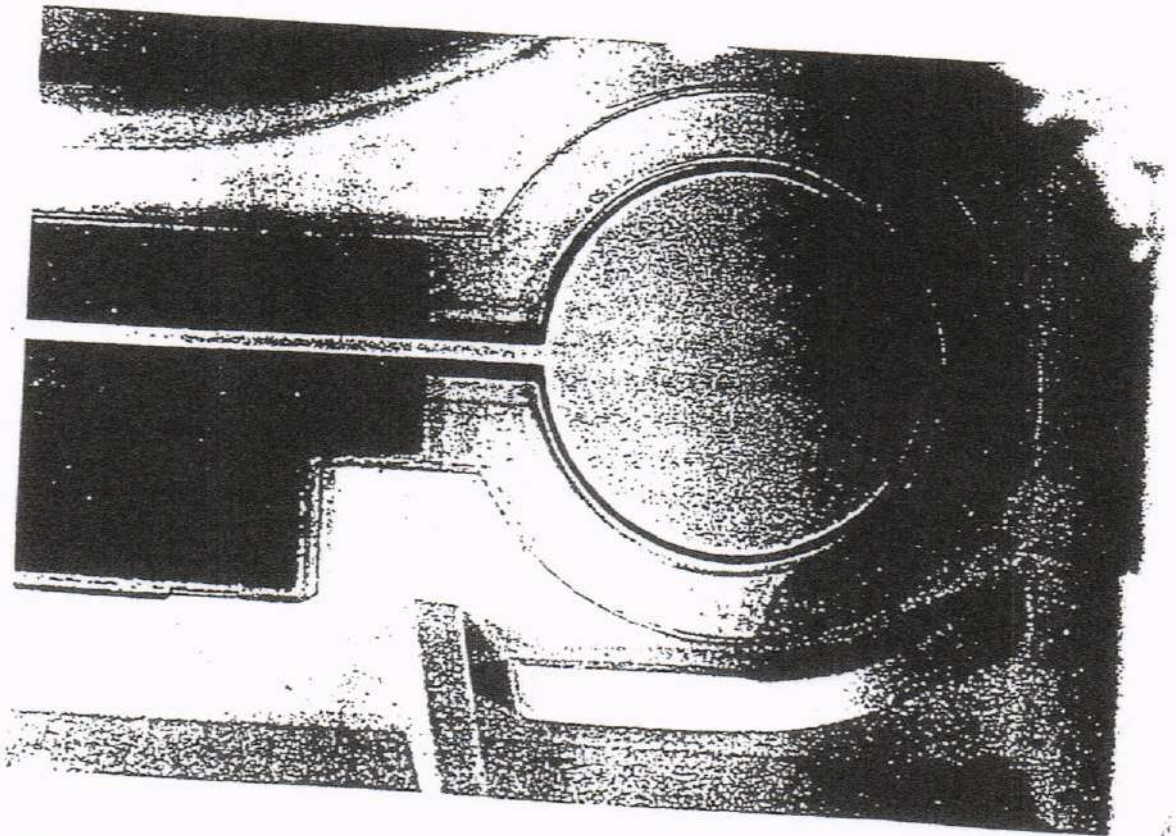
Photo 14. Close-up of the hookswitch bubble showing residue around the top, clear, round section and also under the green area

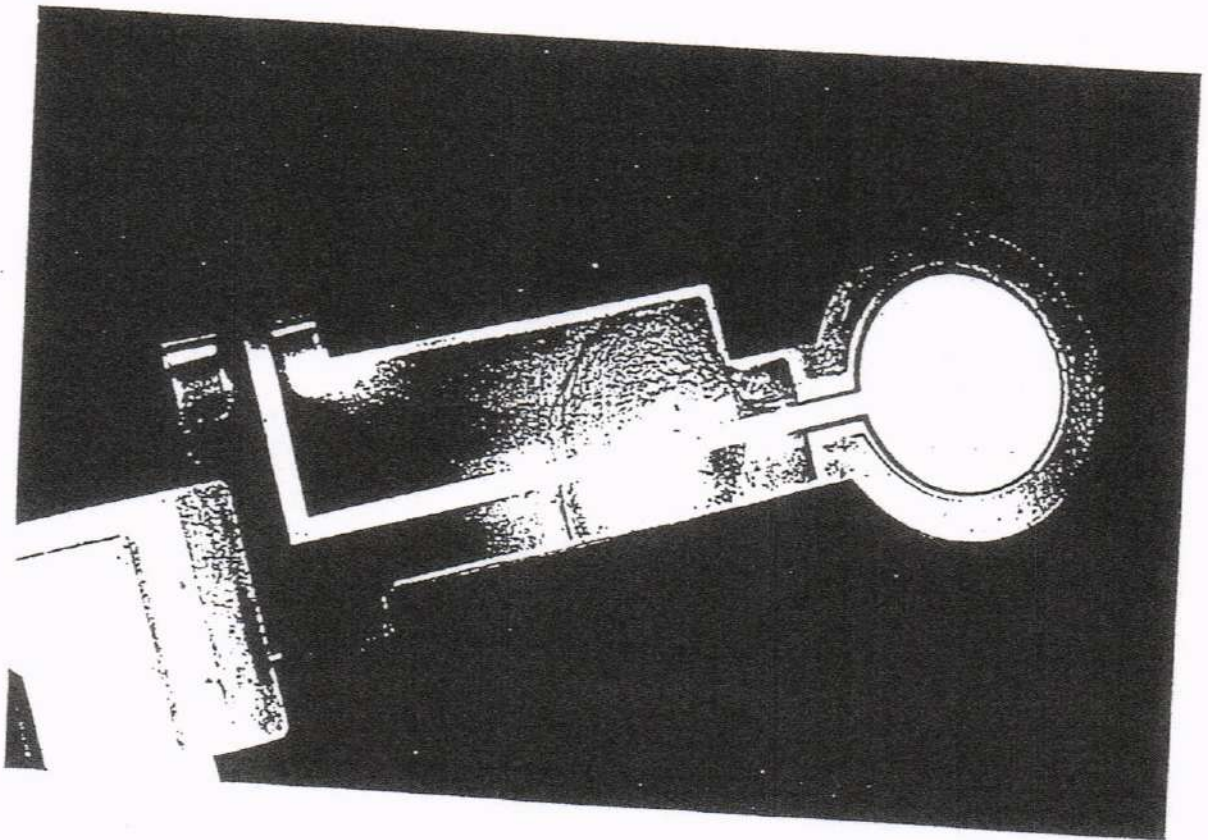
Photo 16. Hookswitch part of the flexible circuit layer showing residue on both the green and clear surfaces

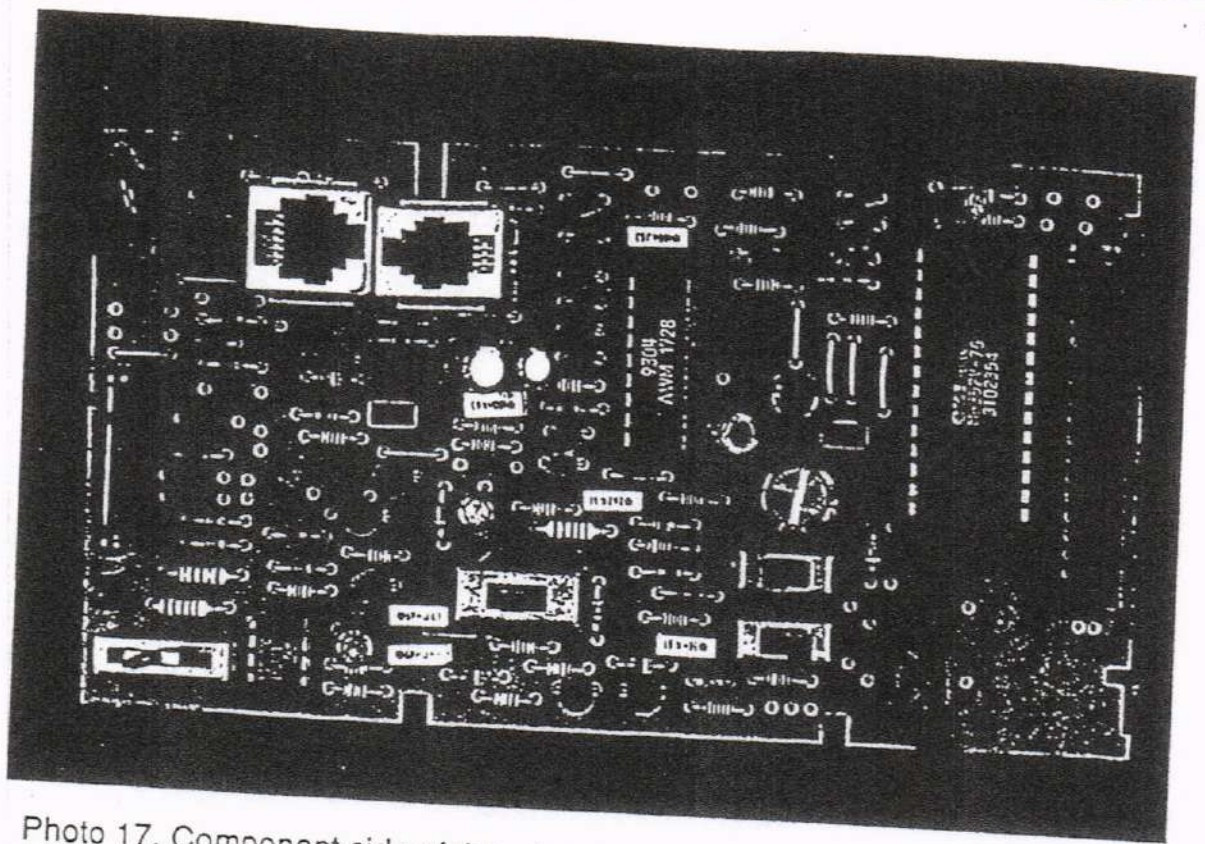
Photo 17. Component side of the printed board assembly showing date code but no evidence of residue

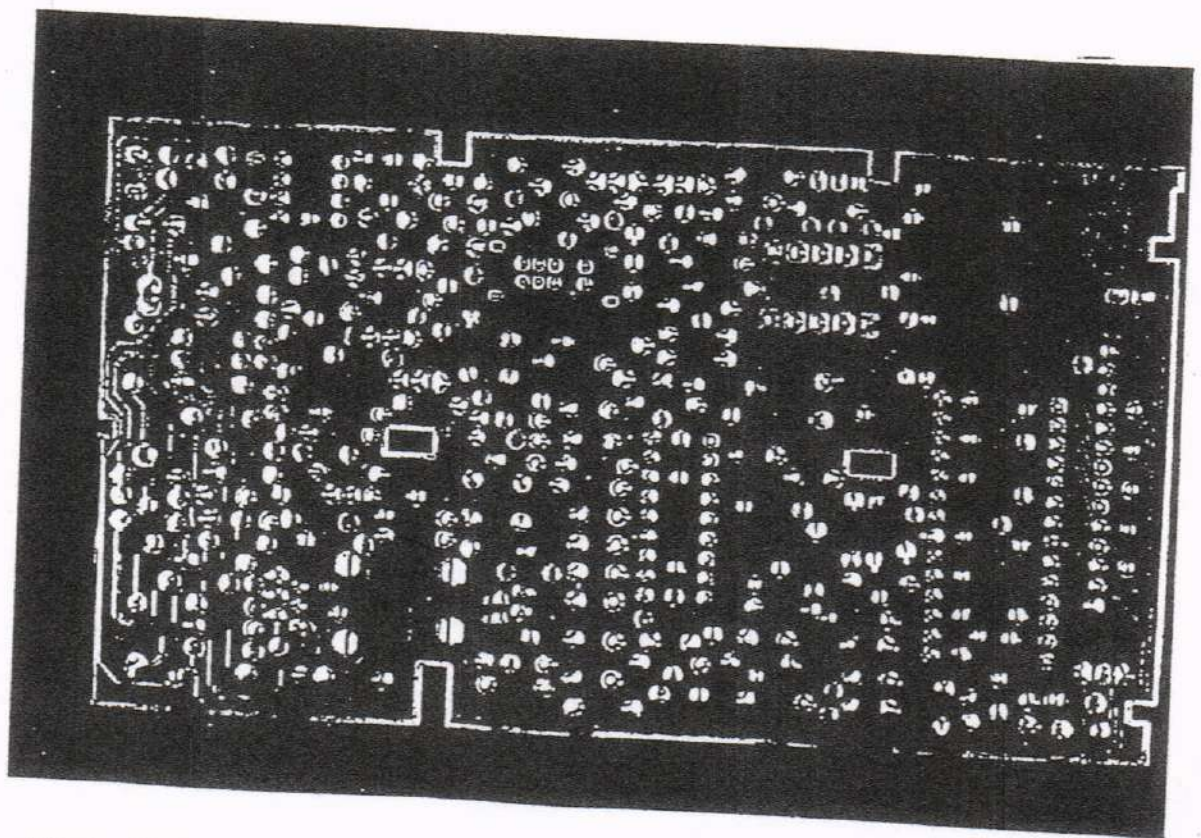
Photo 18. Reverse side of printed board assembly showing manufacturer and revision number but no evidence of residue. (the red colour at the edges is the result of a manufacturing process and is common)

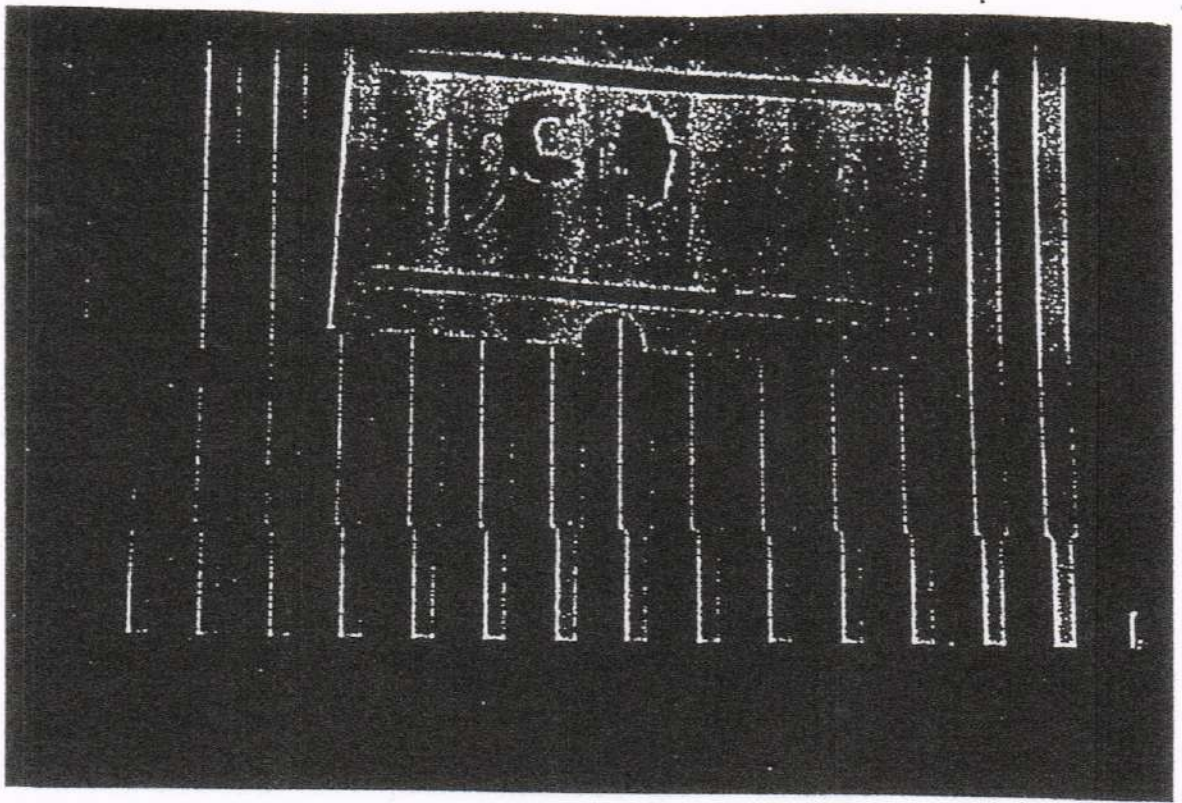
Photo 19. Flexible circuit layer at the edge where it connects to the printed board assembly showing manufacturing date (19/03/93)
