RE: A.F.P. ENQUIRY

Facsimile 055 236 56
From Alan Barrow
P.T.T.O.1
Subject COT Case

On the date of 28-OCT-93 we were trying to create a line failure condition that would re-produce the same error on the transmitting machine and no record on the receiving Mitsubishi machine (055 267 230). The reason for this was to show that a sending fax machine could get to the point of transmitting a page to the Mitsubishi fax machine without the Mitsubishi machine having any record of the call.

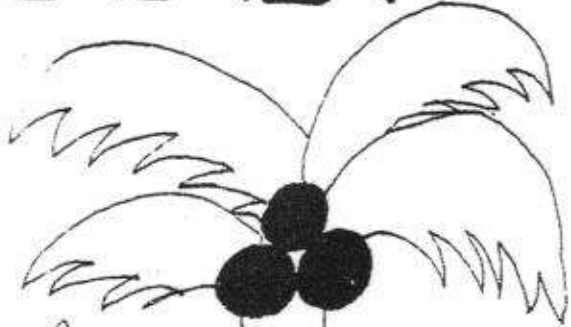
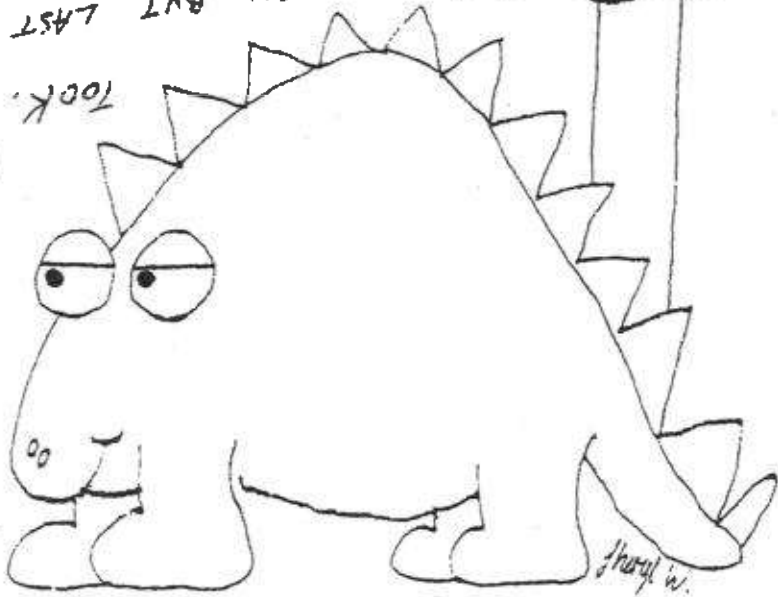
TEST FAX

THIS FAX TO RECEIVE
3.11 MIN.
1 1/2" RECEIVED
ALL BUT LAST PARTY FAX IN
THEN SENDING, MACHINE SILENT
DISCONNECTED, THEN SILENT
RECEIVING FAX. APPROX 2 MIN!
FOR REST OF MESSAGE RECEIVE

STOB APPROX
HERE
