Telecom
AUSTRALIA

RE: A.F.P. ENQUIRY

Subject COT Case

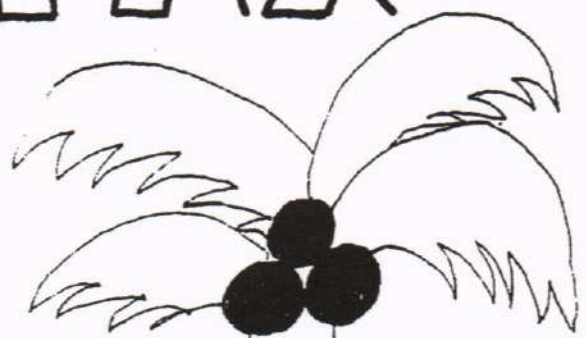
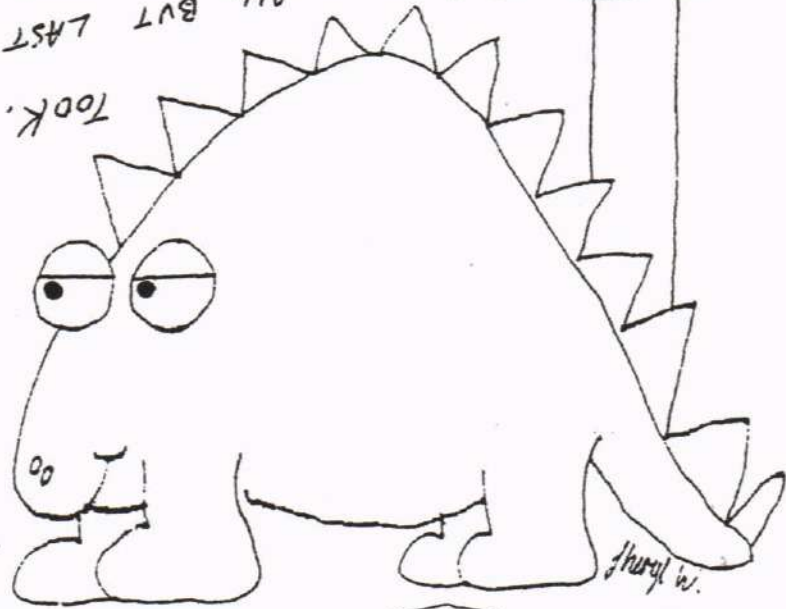
TEST FAX

(STORED IN FAX STREAM ?)

FOR REST OF MESSAGE RECEIVED
RECEIVING FAX. MACHINE SILENT
DISCONNECTED, THEN SENDING
PARTY FAX WITHIN 1 MI.
ALL BUT LAST 1/2" RECEIVED
TOOK. 3.11 MIN. TO RECEIVE
THIS FAX

STOP APPROX
HERE.
