Telecommunications
Industry
Ombudsman

LEVEL 3 COMPLAINT

TIO reference: 02/101638-1 - Mc Kenzie

The Telecommunications Industry Ombudsman (TIO) has received a complaint against Telstra Corporation from Mr & Mrs Darren & Jenny Lewis regarding telephone number 0355267267.

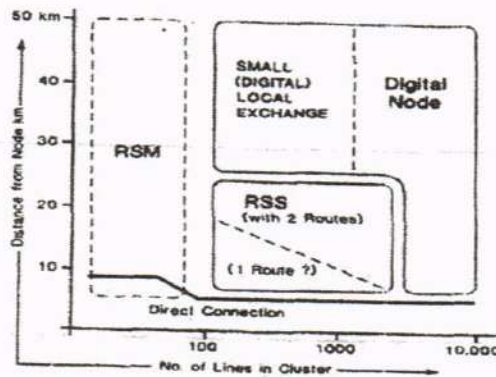
FIG. 13 CHOICE OF CONNECTING EQUIPMENT

(Refer Telecom Aust, Engineer Development Program, Technical Publication TPH 1176, FIG.13)

Customers near the node can be directly connected. Small group of greater distances can be connected by "Remote Subscriber Multiplexer" (RSM) (the term RSM was later changed by Telstra to RCM – Remote Customer Multiplexing when the term Subscriber was replaced by Customer. The term RSM has been used in this report as it was the term utilised at the time in question) over a primary digital line system. Large clusters are best served by "remote switching stage" (RSS).

3.1. The network is made up of a hierarchy of exchanges. However, the type and selection of the specific connecting equipment depends on the number of customers in a cluster, and the distance of this cluster from the node or terminal exchange.
